# ORBITER TILE IMPACT TESTING

Final Report

SwRI Project No. 18-7503-005

NASA  
Johnson Space Center  
Houston, Texas

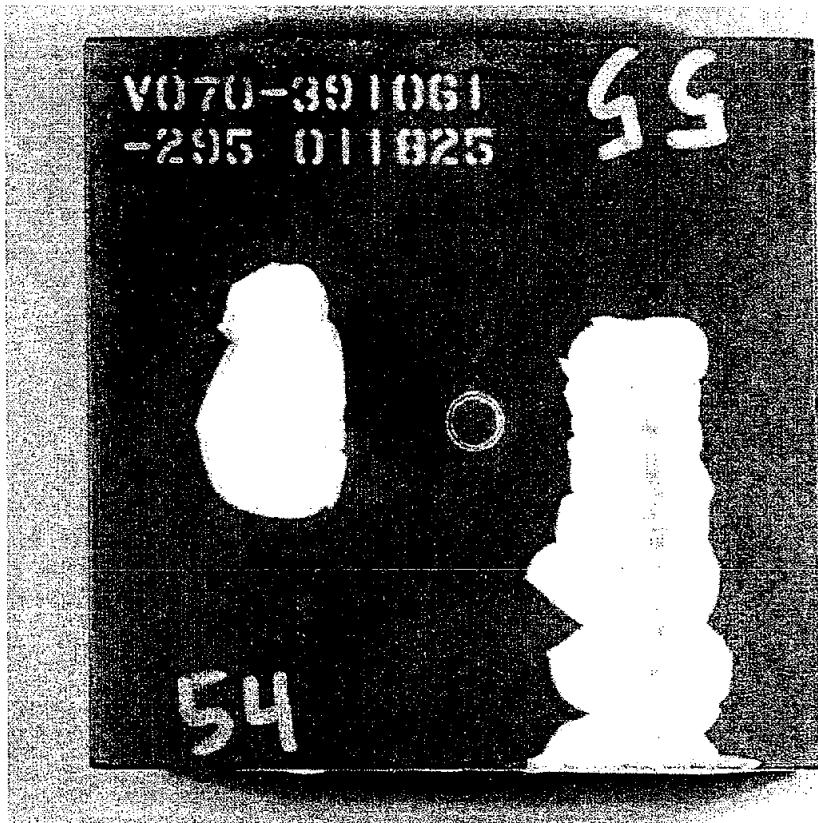
**Figure No. 11: Photograph of damaged tile**

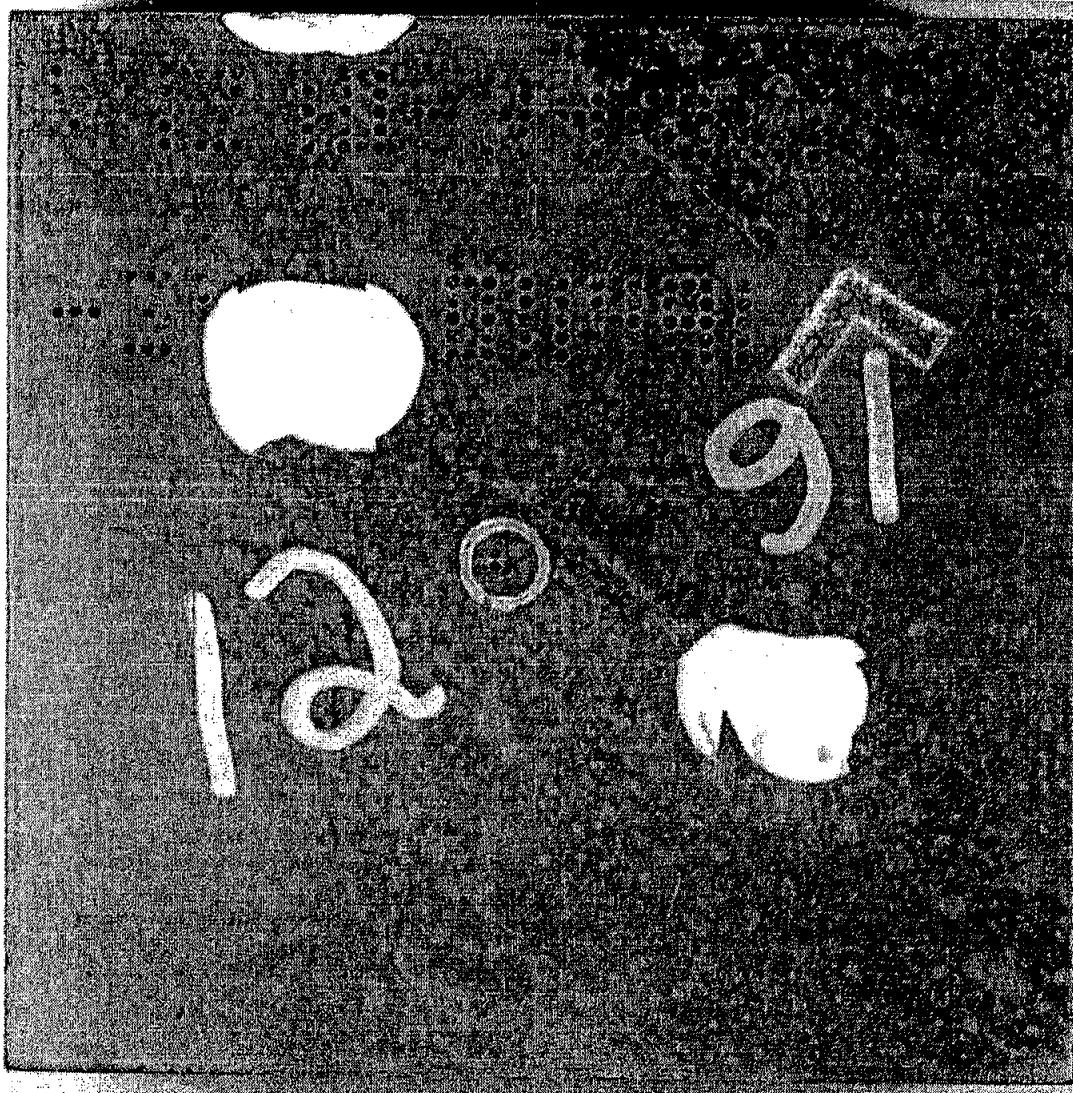
Tests No. 12 and 16

14	825	30	No	*****	*****	Velocity (+25 fps)	*****
15 (A)	1160	30	Yes	Shallow Crater, Loss of Coating	0.94 x 1.25" x 0.13"	Velocity (-40 fps)	0.03
16 (B)	1605	30	Yes	Crater	1.34" x 1.1" x 0.26"	Velocity (+5 fps)	0.13
17	516	40	No	*****	*****	Velocity (+116 fps)	*****
18	799	40	Yes	Delamination and Cracking of Coating	0.66" x 0.98"	Velocity (-1 fps)	*****
19 (D)	1252	40	Yes	Crater	1.0" x 1.1" x 0.41"	Velocity (+52 fps)	0.19
20 (F)	1520	40	Yes	Crater	1.44" x 1.2" x 0.47"	Velocity (-80 fps)	0.24
81	750	10	No	*****	*****	Velocity (-50 fps)	*****
82	1553	10	No	*****	*****	Velocity (-47 fps)	*****
89	785	23	No	*****	*****	Velocity (-15 fps)	*****
90 (B)	1640	23	Yes	Shallow Crater, Loss of Coating	1.1" x 1.15" x 0.11"	Velocity (+40 fps)	0.03

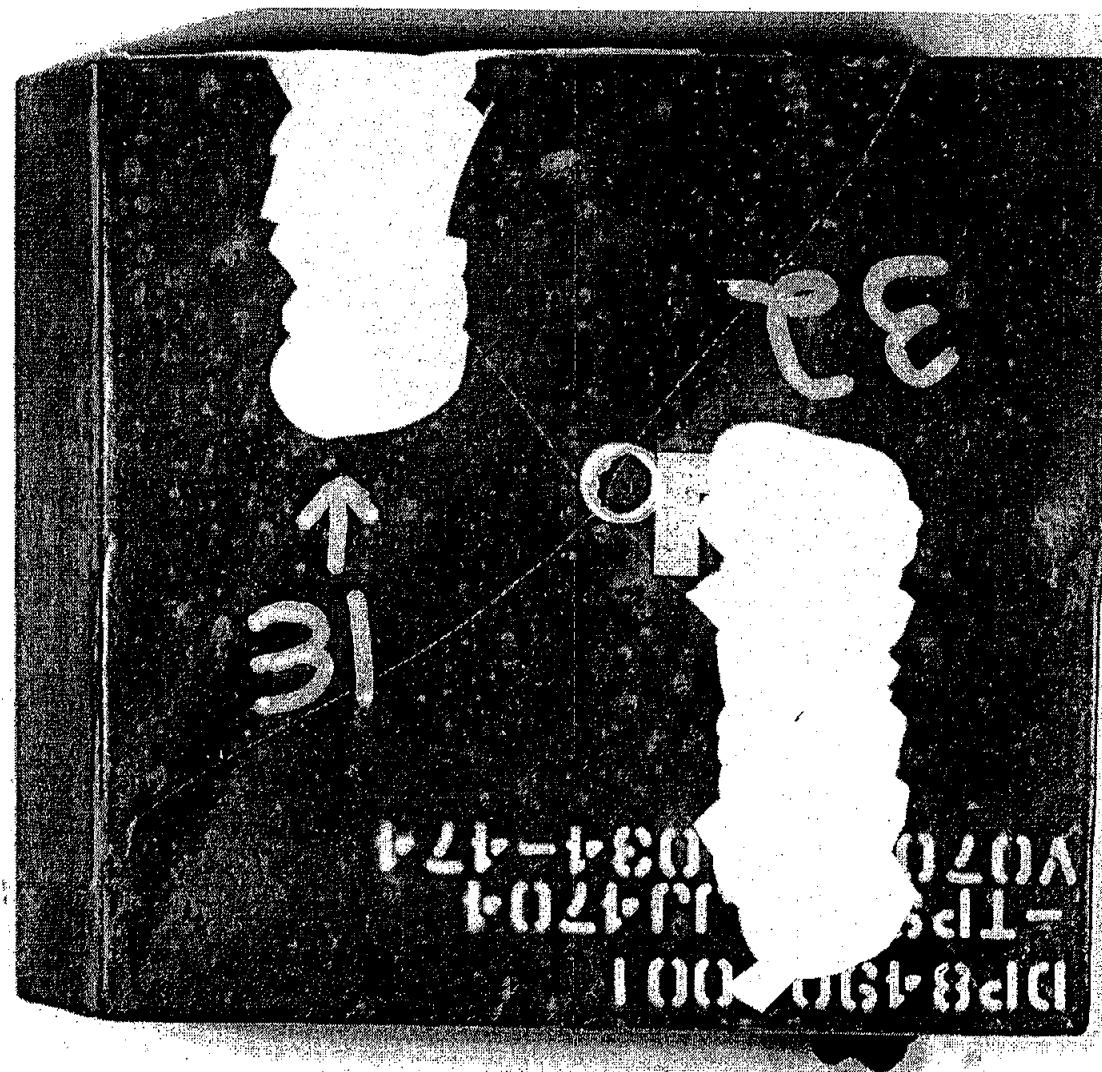
Tests No. 31 and 32

32	1557	23	Yes	Crater	3.75" x 1.5" x 0.4"	Velocity (-43 fps)	0.64
33	452	30	No	*****	*****	Velocity (+52 fps)	*****
34 (A)	805	30	Yes	Crater	2.0" x 1.25" x 0.25"	Velocity (+5 fps)	0.13
35	1240	30	Yes	Crater	2.25" x 1.38" x 0.4"	Velocity (+40 fps), Projectile Cracked	0.47
36 (A)	1483	30	Yes	Crater	2.5" x 1.5' x 0.5"	Velocity (-117 fps), Projectile Slightly Broken Up	0.58
37	447	40	No	*****	*****	Velocity (+47 fps)	*****
38	767	40	Yes	Crater	1.5" x 1.25" x 0.38"	Velocity (-33 fps), Projectile lost a small piece	0.21
39	1216	40	Yes	Crater	2.5" x 1.1" x 0.5"	Velocity (+16 fps)	0.65
40 (A)	1616	40	Yes	Crater	3.0" x 1.5" x 0.5"	Velocity (+16 fps), Projectile Slightly Broken Up	0.61
83	790	10	No	*****	*****	Velocity (-10 fps)	*****
84 (B)	1710	10	Yes	Shallow Crater, loss of Coating	**2.25" x 1.63" x 0.10"	Velocity (+110), Extended to Tile Edge	0.08
91	794	23	Yes	Crater	1.7" x 1.21" x 0.24"	Velocity (-6 fps)	0.17

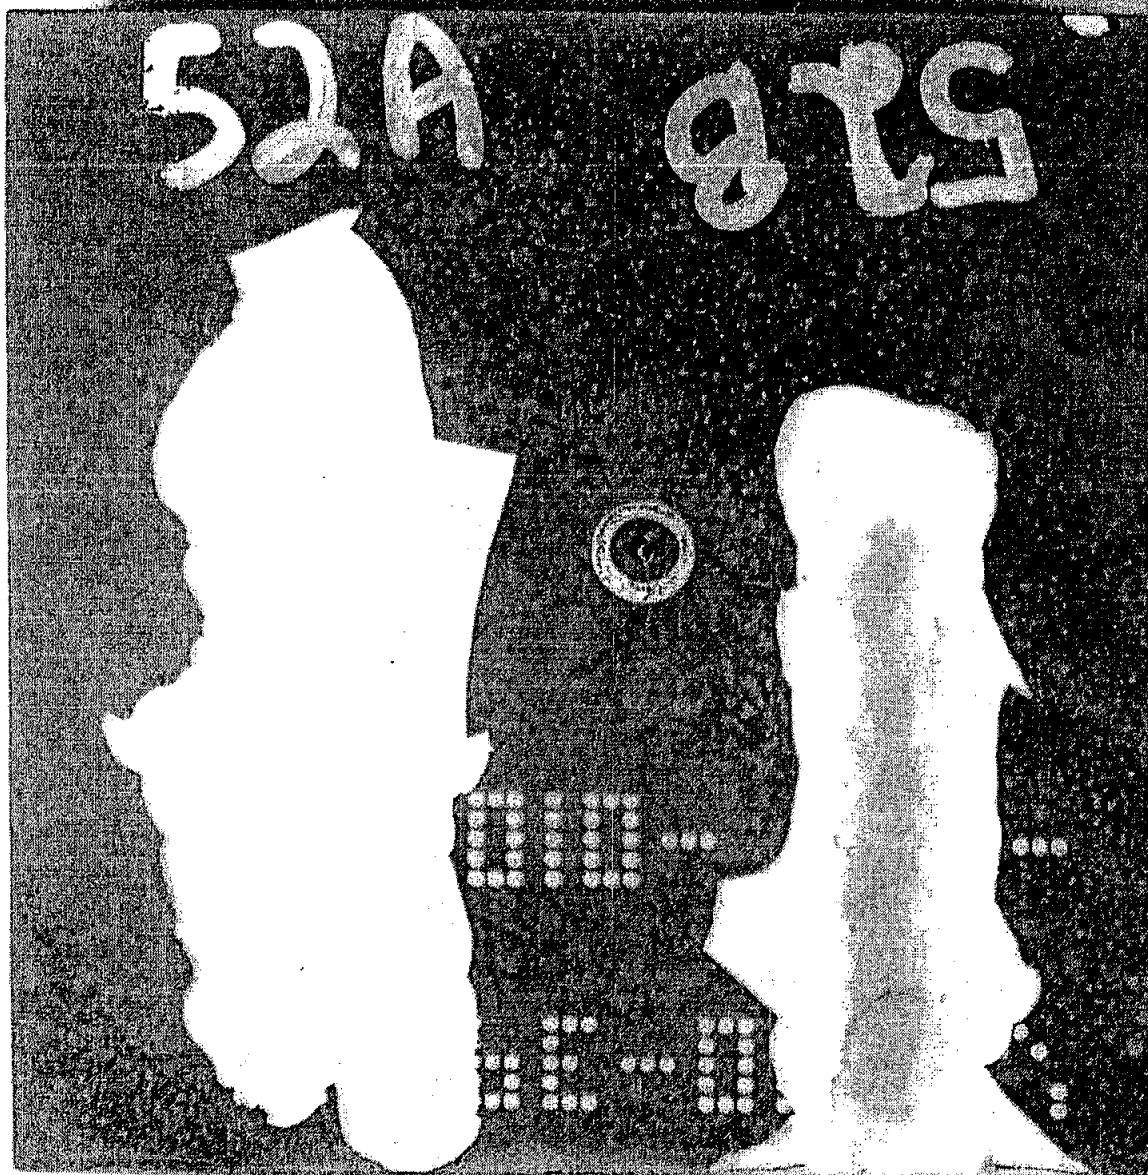
Tests No. 52A and 52B

52 (B)	1588	23	Yes	Crater	**4.0" x 1.1" x 0.8"	Velocity (-12 fps), Extended to Tile Edge	2.59
53	410	30	No	*****	*****	Velocity (+10 fps)	*****
54	803	30	Yes	Shallow Crater, Loss of Coating	2.0" x 1.25" x 0.08"	Velocity (+3 fps)	0.17
55	1161	30	Yes	Crater	**3.65" x 1.5" x .75"	Velocity (-39 fps), Extended to Tile Edge	2.01
56	1386	30	Yes	Crater	4.13" x 2.75" x 0.6"	Velocity (-214 fps), Projectile Slightly Broken Up	1.83
57 (A)	467	40	Yes	Delamination and Cracking of Coating	0.75" diameter x 0.13" deep	Velocity (+67 fps)	0.01
58	801	40	Yes	Crater	2.5" x 1.2" x 0.4"	Velocity (+1 fps)	0.76
59 (A)	1126	40	Yes	Crater	4.5" x 2.0" x 1.0"	Velocity (-74 fps)	2.30
60	1432	40	Yes	Crater	**6.0" x 3.0" x 2.0"	Velocity (-168 fps), Projectile Broke Up	Unmeasurable
85	980	10	No	*****	*****	Velocity (+180 fps)	*****
86	1577	10	Yes	Shallow Crater, Loss of Coating	**2.56" x 1.7" x 0.11"	Velocity (-23 fps)	0.13
93	870	23	Yes	Crater	2.25" x 1.32" x 0.27"	Velocity (+70 fps)	0.37

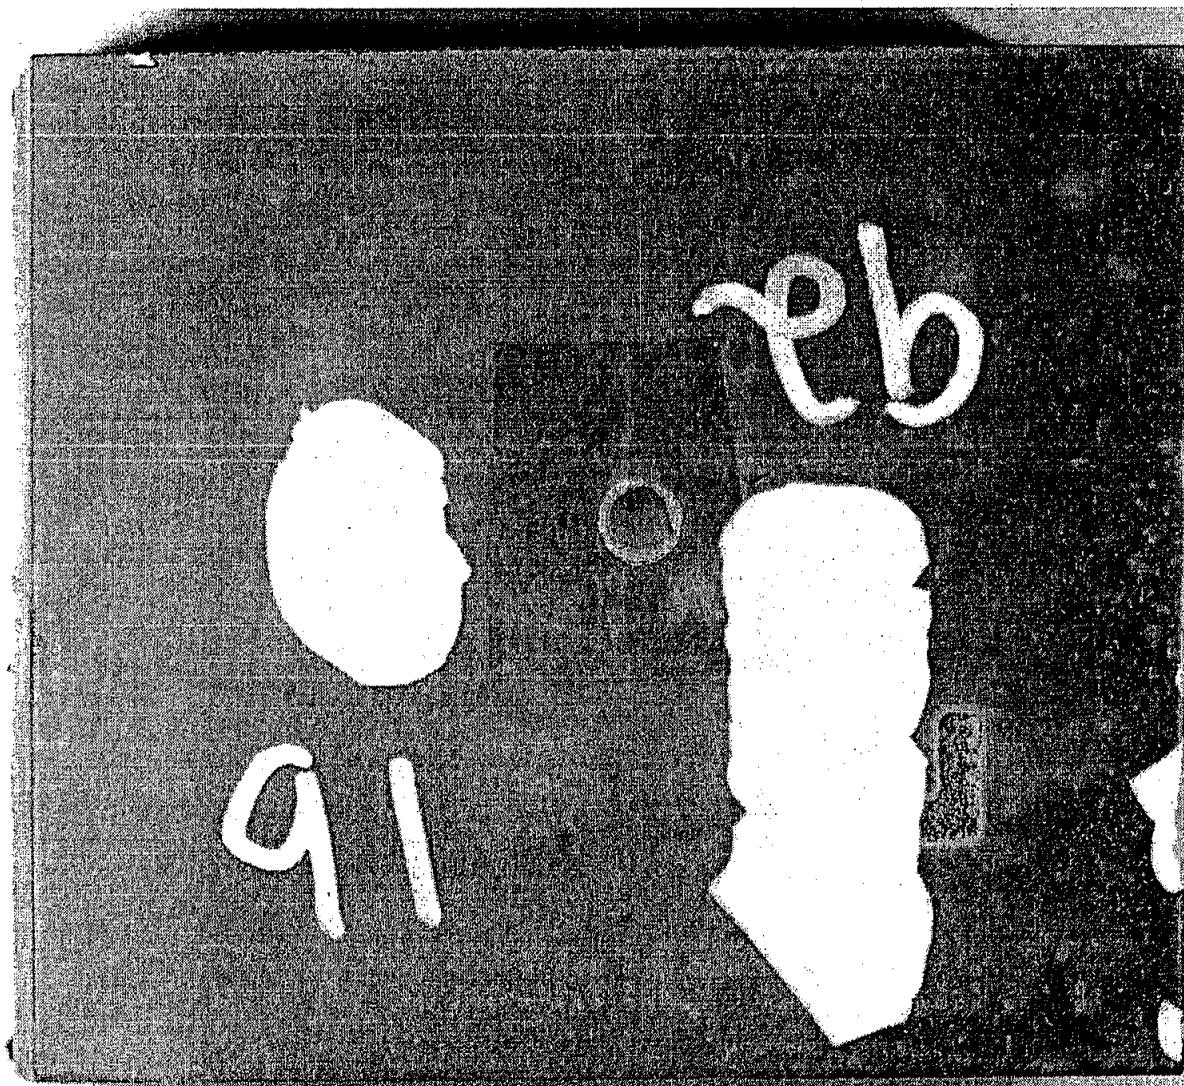
Tests No. 91 and 92

92	1596	23	Yes	Crater	3.35" x 1.4" x 0.40"	Vel. (-4 fps), Proj. Slightly Broken Up	0.67

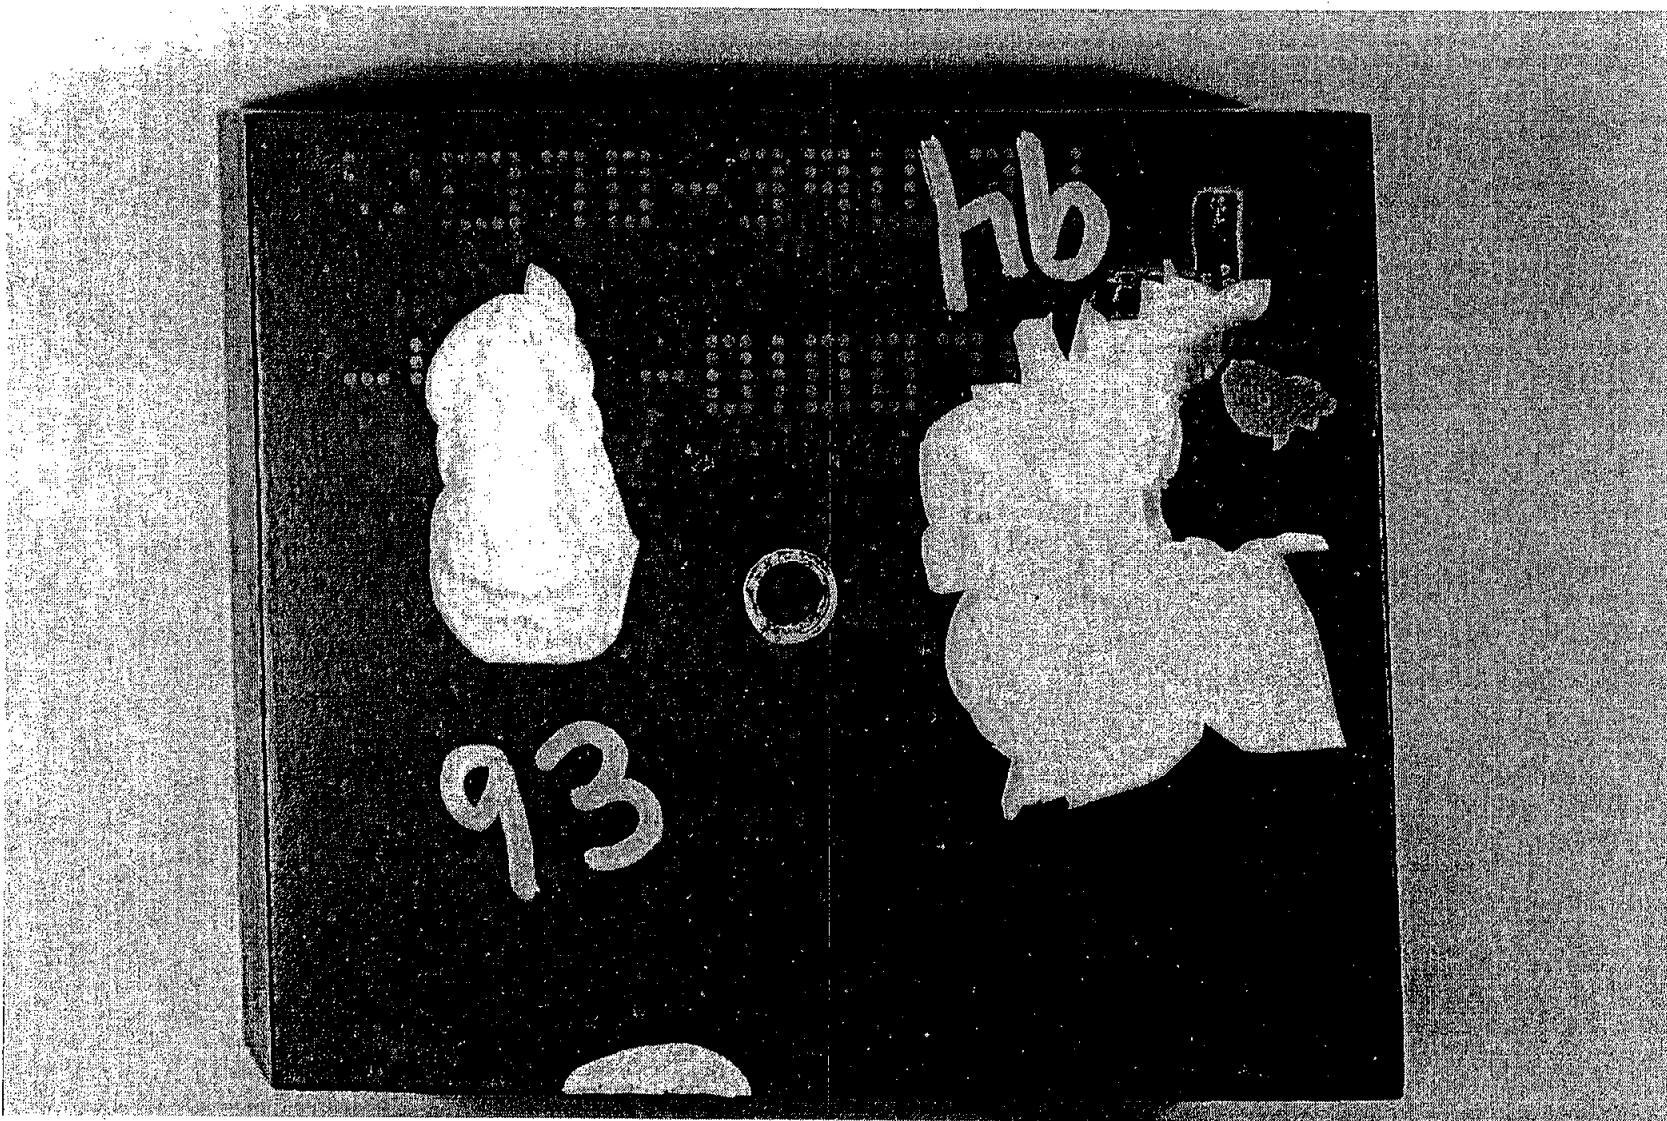
Tests No. 93 and 94

94 (A)	1520	23	Yes	Crater	**5.02" x 1.61" x 0.65"	Velocity (-80 fps), Slightly Cracked Proj.	2.02

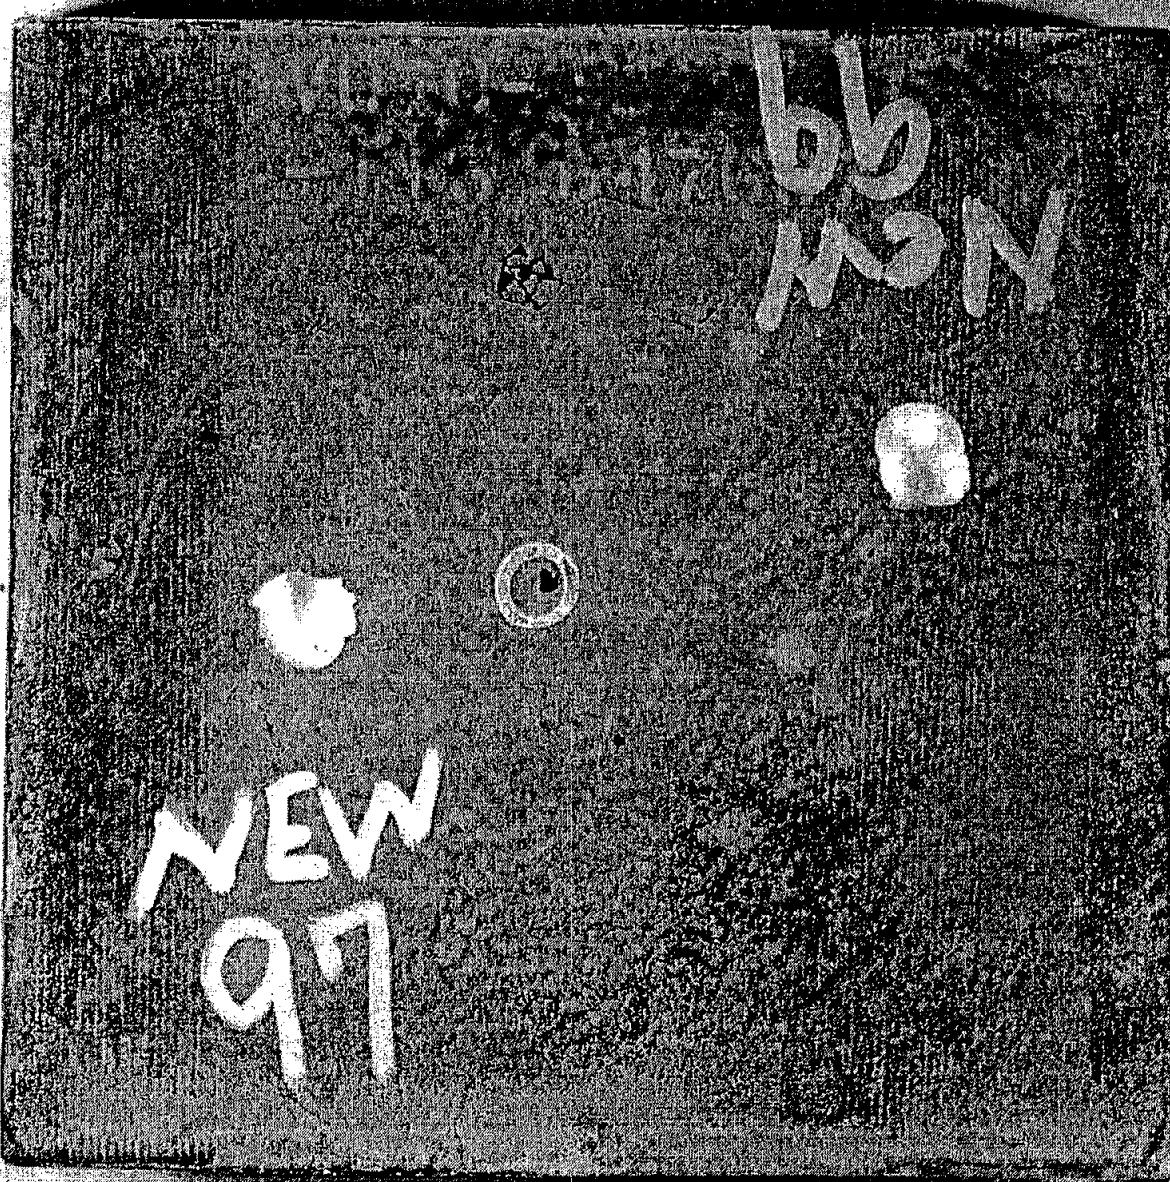
Tests No. 97 and 99

Test No.	Projectile	Velocity	Impact Angle	Damage	Damage Type	Damage Max. Dimensions (Length x Wide x Depth)	Comments	Damage Volume (cubic inches)
	Length	(fps)	(degrees)	(Yes or No)				
97	1.0"	1000	60	Yes	Crater	0.53" dia. X 0.35" deep	Velocity (-9 fps), This is the New Test 97	0.05
98 (A)	1.0"	1692	30	Yes	Crater	1.07" x 0.56" x 0.36"	Velocity (+72 fps), New Test 98A	0.10
99 (B)	1.0"	730	60	Yes	Crater	0.62" dia. x 0.15" deep	Velocity (-5 fps), This is the New Test 99B	0.02
100	1.0"	929	30	No	*****	*****	Test No. 97 in NoteBook, Vel (-31 fps)	*****
101 (B)	3.0"	1317	30	Yes	Crater	1.85" x 1.08" x 0.5"	Velocity (+111 fps), New Test 101B	0.18
102	3.0"	1317	30	Yes	Crater	1.85" x 1.08" x 0.5"	Velocity (+111 fps), New Test 101B	0.18
103	3.0"	1071	30	Yes	Crater	1.5" x 1.0" x 0.5"	Velocity (+46 fps), New Test 103	0.17
104	3.0"	1250	60	Yes	Crater	1.01" dia. X 0.9" deep	Velocity (+50 fps), New Test 104, Proj. Slightly Broekn Up	0.15
